## **Existing Private Road Dedication Evaluation Spring Lake Hills Condominiums 3/21/18**

Spring Lake Hills Condominium Association (SLHCA), located at 120 Spring Lake Drive submitted a letter requesting that the Village assume ownership and maintenance responsibilities for their existing private roads within the subdivision.

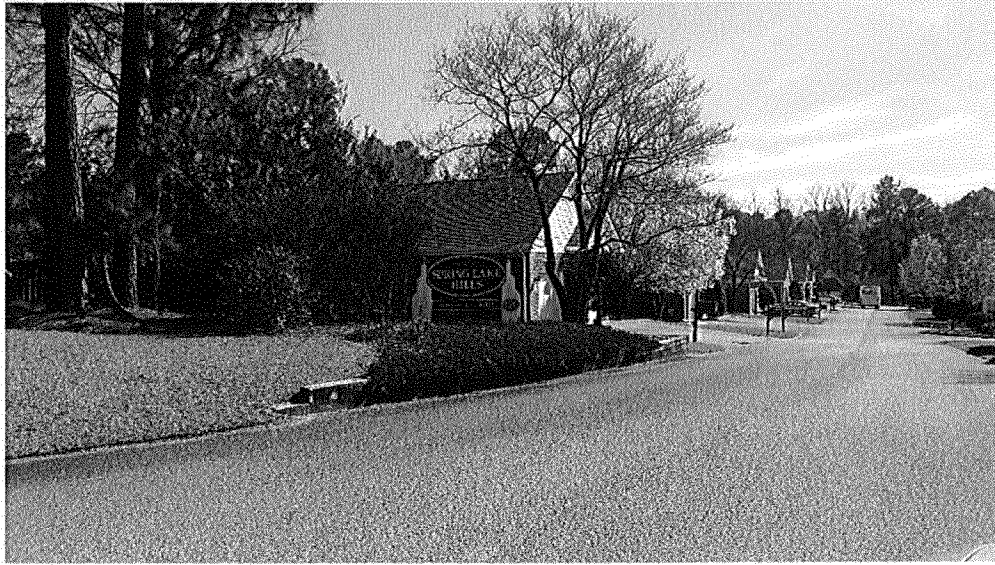
Photograph 1 – Sign

- One entrance provides access into the subdivision from Spring Lake Drive. A subdivision sign (Appendix B - Photograph 1) is located at the entrance on SLHCA property and there is no street sign at the entrance.

- A Village street name sign would need to be installed at the entrance and one internal to the subdivision. Estimated cost is \$150.
- Private utilities for irrigation and decorative street lights would have to be granted an encroachment agreement in order to remain if they fell within a proposed right-of-way. The existing decorative street lamps exceed the Village's standard for neighborhoods and would remain the SLHCA responsibility if not switched to the Village's standard neighborhood street light. There is a provision in the street light policy that would permit a reimbursement for eligible lights at the standard light rate with excess cost being borne exclusively by the SLHCA.

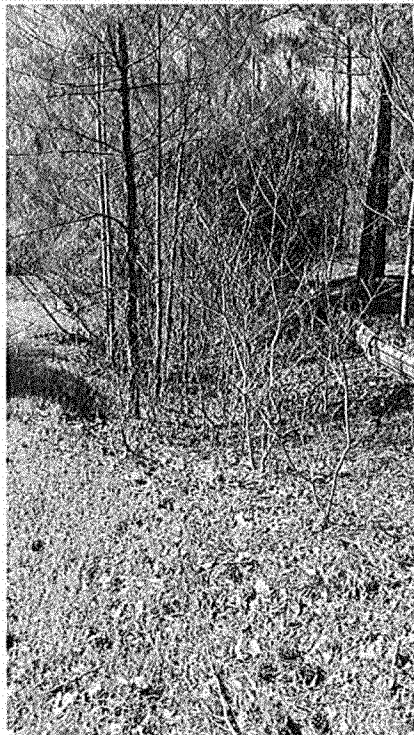
Photograph 2 – Basin 1

- Drainage facilities include two overgrown stormwater basins (Appendix B - Photographs 2 and 3). The majority of streets transfer stormwater to the road shoulder and eventually to the stormwater basins. Defined side ditches are not present and most of the flow appears to reach the basins by sheet flow or via a rock-lined ditch that starts at the edge of pavement and then progresses between two buildings to a basin (Appendix B – Photograph 4). A speed hump (Appendix B – Photograph 5) is used to direct the flow from the road surface to the rock-lined ditch. Along the cul-de-sac, there is a rock flume (Appendix B – Photograph 6) and two speed bumps that appear to be attempts to slow and direct stormwater flow (Appendix B – Photograph 7).

- The existing drainage basins would remain the property and maintenance responsibility of the SLHCA. The two speed bumps and one speed hump present for stormwater would need to be removed to meet standards and an alternative means to control stormwater runoff would be necessary.

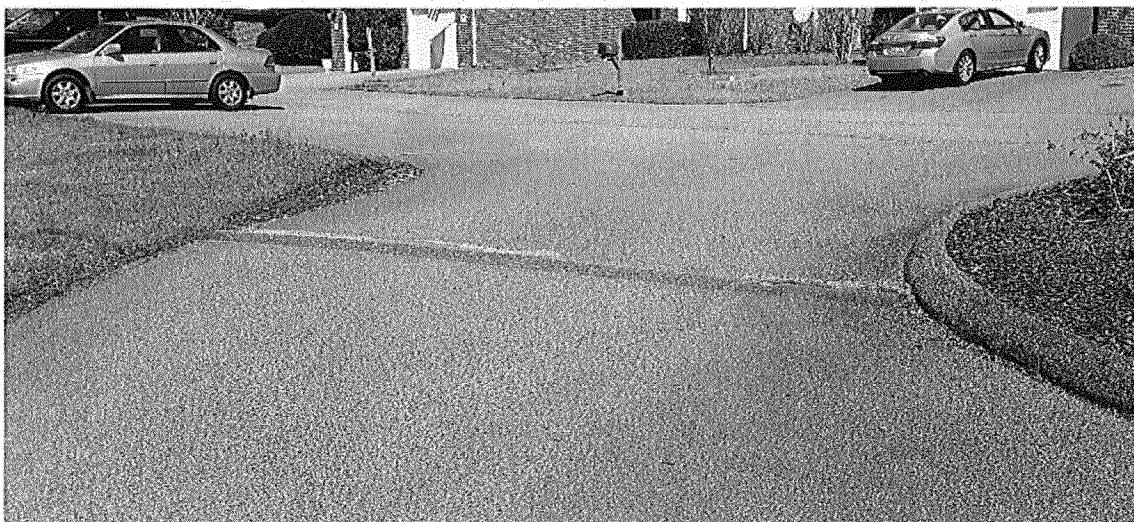
Photograph 7 – One of Two Speed Bumps

| <b>Planning/Zoning Conditions:</b> | Field evaluation(s) and review of plats will be conducted to determine presence of, requirements for the list below. This list may be amended as needed on a case by case basis. | | | |
|---|---|---|---|---|
| Road(s) platted/private | | Private | | Roads are part of common grounds. Two speed bumps present in cul-de-sac. |

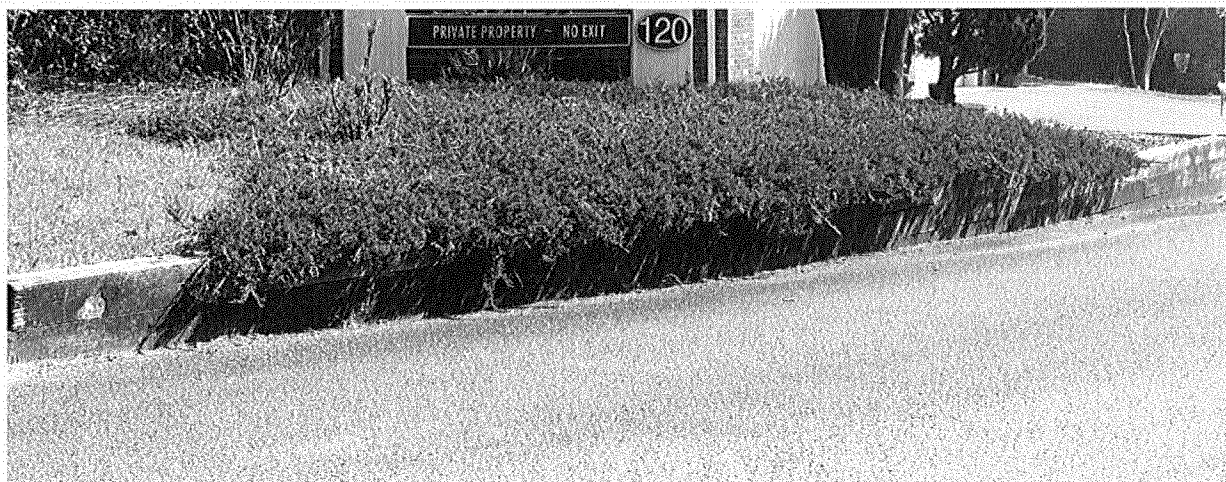
Photograph 8 – Timbers

- Water mains and gravity sewer lines are owned and maintained by MCPU. Appendix C shows line and manhole locations. Existing fire hydrants (3) are periodically spaced along the road shoulder.
- The Village currently provides trash and recycling pickup services with individual carts assigned to units.
- Each condominium unit has its own mailbox and an asphalt driveway with garage.
- There's one landscape timbered wall adjacent to the pavement (Appendix B - Photograph 8).

- The landscape timbered wall could only remain if an encroachment agreement were granted.

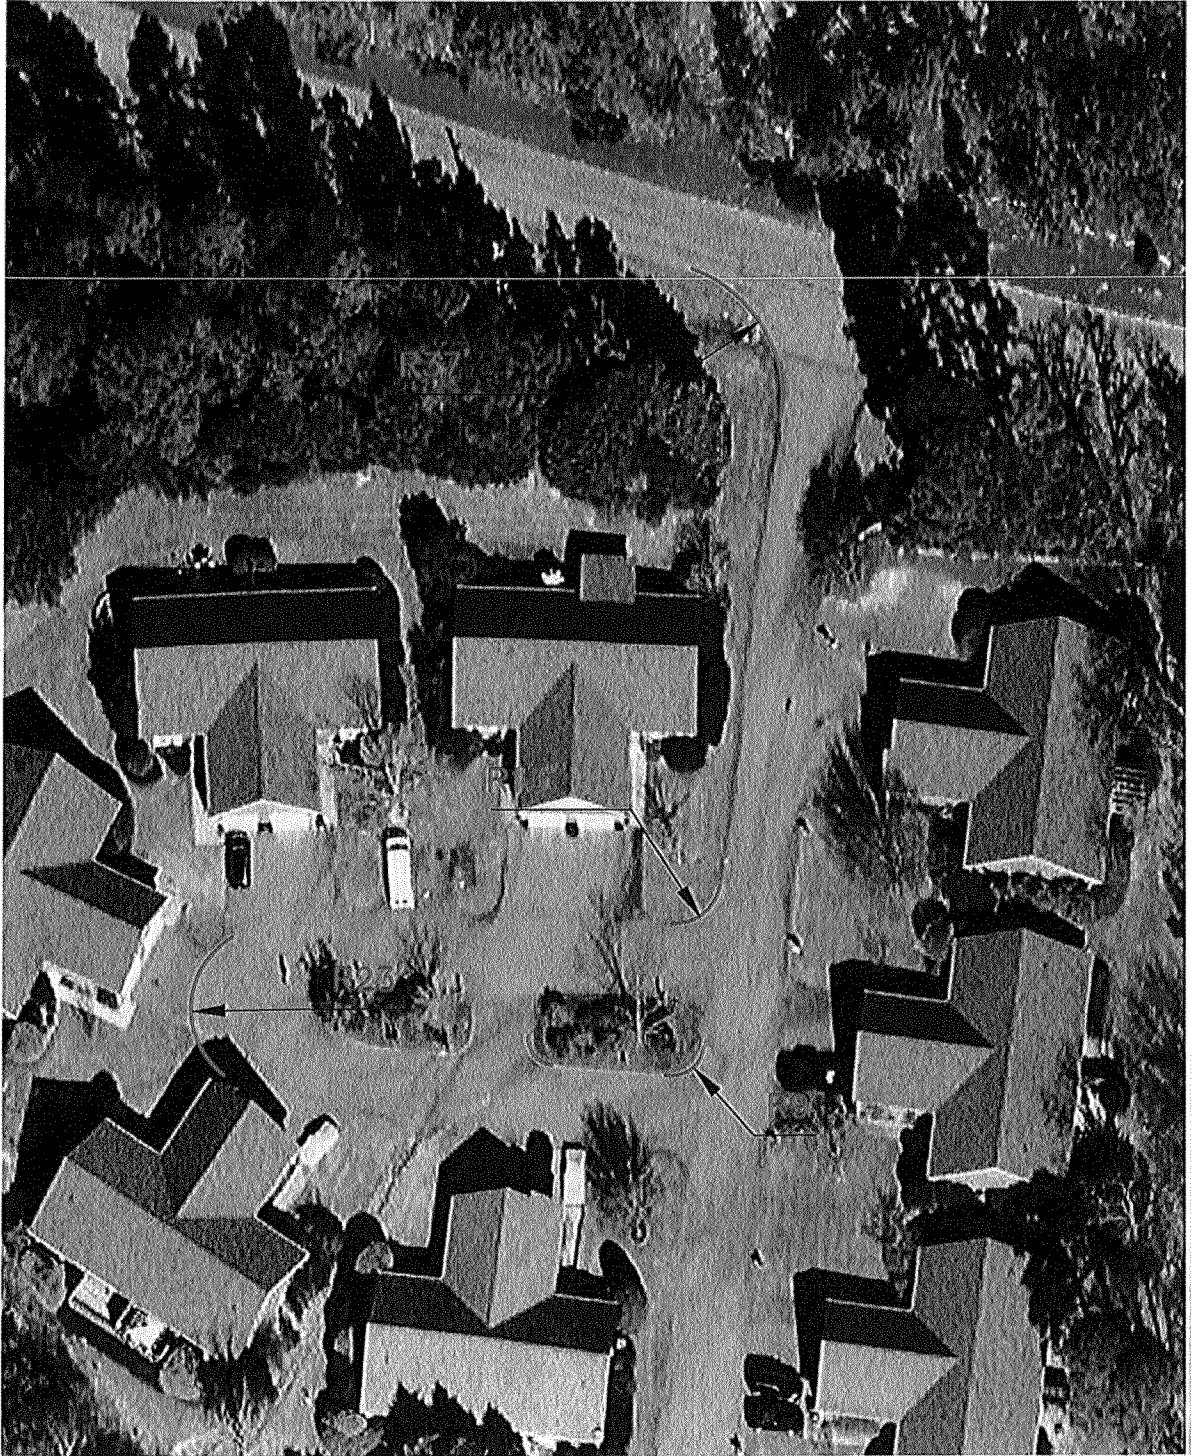
## Appendix D – Turning Radius

- The roads likely met Village standards in place at the time of development for sub-base and asphalt thickness and staff would estimate the PCR between 50 and 60. Only one turning radius meets Village standards (Appendix D).

| <b>Road Conditions:</b> | The requesting party shall pay for up to one core sampling for every tenth of a mile being petitioned for acceptance to determine if roads meet VOP standards and to determine what is necessary to bring up to meet the standards. | | | |
|---|---|---|---|---|
| Turning radii | 30' | Varies | | The main entrance road meets the standard, the remaining internal turning raidus do not meet standard. |
